Manhole Inspection Summary

Manhole # S03AA2011MH

Location Address: **6100 CROSS COUNTRY BLVD** Cross Street: **TANEY RD**

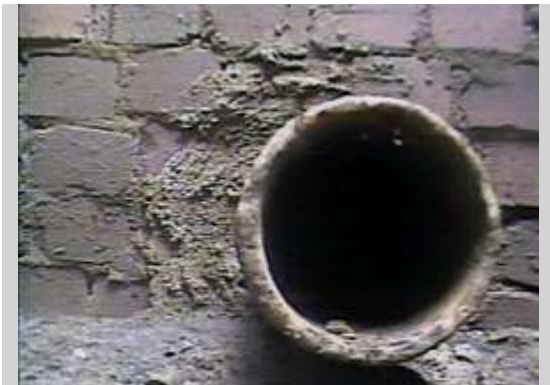
4 in. Circular Gravity Sewer Pipe In @ 3 O'Clock

Pipe Material: **DIP/CI** ☐ Pipe Lined

Infiltration: **None** Pipe Seal Cond: **Unknown**
